DGS DIESEL + GETRIEBE + SERVICE DISTRIBUTOR IN DEUTSCHLAND					<h1>Service Report</h1>

Tel.:					+998981772552			+998981772552		
Fax:										
email:		yangwei@yutong.com, Jason Ding			info@tashbus.uz			info@tashbus.uz		
Customer Purchase order #:		Per email of 02.06.2023						Customer PO Date:		02.06.2023
Repairing Outlet (Allison Dealer)					Global Industrial Solutions					
Transm. Model:		T375			PN:		E027061		SN: 6511879677	
Replacement Transmission:					PN:				SN: 6520238396	
TCM, ECU, or Shift Sel.					PN 2:		63CR0YQ8		SN 2:	
Replacement TCM, ECU, or Shift Sel.					Replacement PN 2:				Replacement SN 2:	
Non-Allison Part					PN 3:				SN 3:	
Application:		City Bus			OEM:		Yutong		Model: ZK6126HG	
Application Code:		BU02								
vehicle ID #:		LZYTGMGEF8P1003793			Registr.plate:				Engine:	
In Service Date:		23.05.2023			Veh. hours:				Veh.km: 14834	
Pre Delivery		YES		NO	X	Claim Type:				Field Action # or Activity Indicator
Date in Service after last repair, or Date in Service of exchange unit if failed unit was repaired once before, or if failed unit is already a replacement (SWING) Transmission :

Travel Time:					Travel km if company car used:				PFPN: tbd	
Labor Last Appli

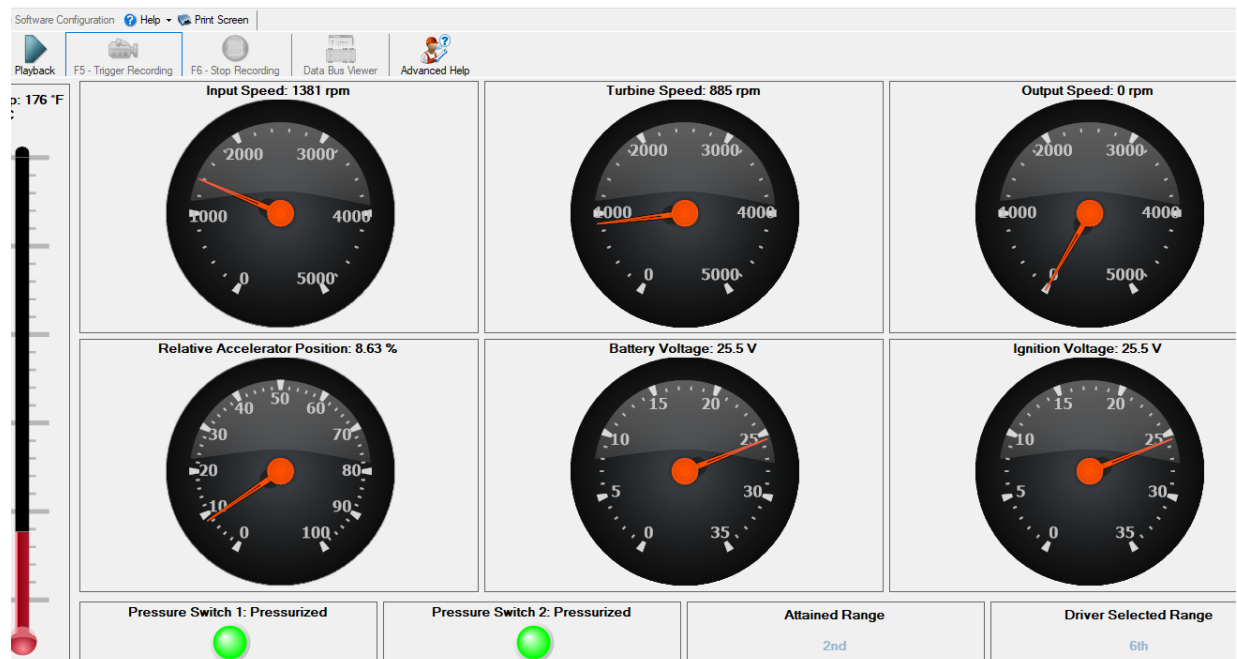
- Checked all connectors and wiring. Visually ok.
- Performed clutch test with Allison DOC Diagnostic tool, supported by a pressure test. **Found slip in 2nd range and in 6th range**, and found C4 clutch pressure slightly lower than Main and than C1 and C2 respectively. All other ranges are ok. This indicates C4 clutch is slipping under load, caused by reduced C4 clutch pressure . See DOV Snapshot file 6511879677-ClutchTest_slip.ad4 , file time 00:01:26 and 00:02:35 (Bookmark #1 and #2) and file time 00:03:17 (Bookmark #3)

Transmission needs to be replaced and needs to be disassembled for further diagnosis and failure analysis.

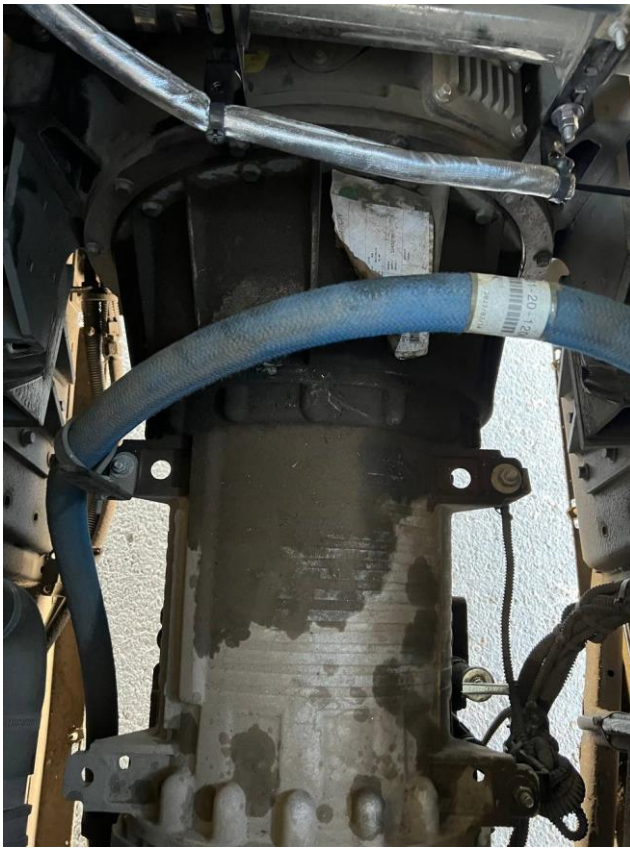
The transmission is wet of oil on the upper front part. Likely from breather blow-out or from another source of oil from above.

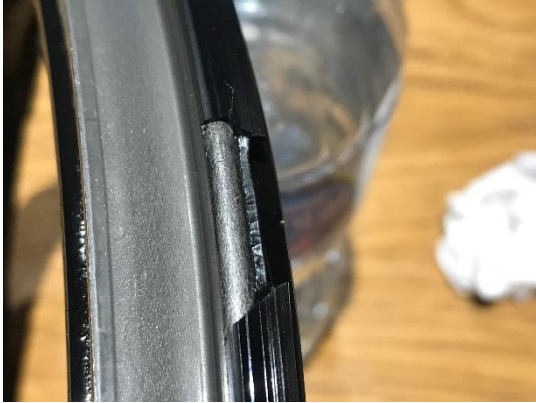
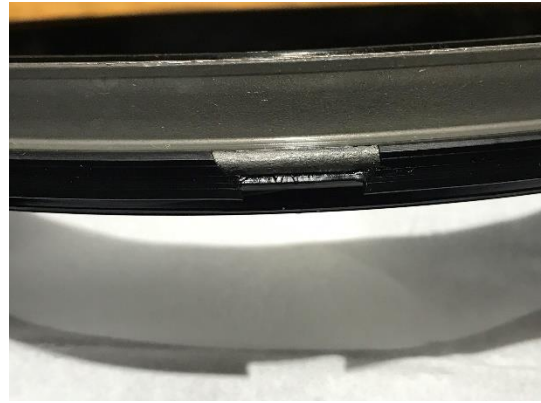
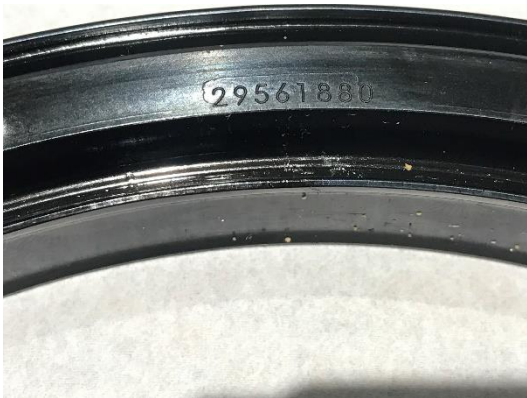
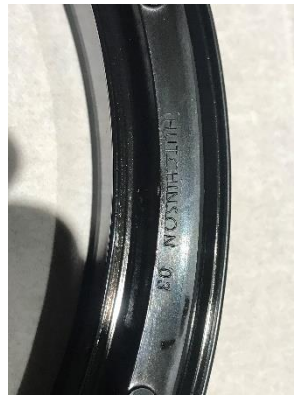
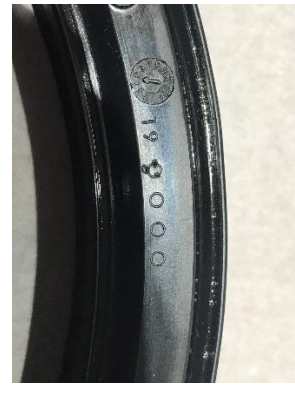
Cause: Slipping C4 clutch, as found by clutch test and t/shooting and as found later during disassembly of transmission. C4 clutch piston seal ruptured causing pressure loss.

Disassembled unit, found C4 piston lip ruptured. But C4 clutch friction- and reaction plates had already severely suffered and needs to being replaced too.

- The ruptured segment of the C4 piston lip was found in the suction screen.
- No evidence of coolant or water. No corrosion.

Ordered new parts.

Overhaul to being continued when new clutch plates will be on stock at new dealer at Tashkent.
