<b>DGS</b> DIESEL + GETRIEBE + SERVICE DISTRIBUTOR IN DEUTSCHLAND					<h1>Service Report</h1>

<b>ZIP Code</b>										
<b>Province:</b>										
<b>Contact:</b>		Yang Wei								
<b>Tel.:</b>					+998981772552			+998981772552		
<b>Fax:</b>										
<b>email:</b>		<a href="mailto:yangwei@yutong.com">yangwei@yutong.com</a>			<a href="mailto:info@tashbus.uz">info@tashbus.uz</a>			<a href="mailto:info@tashbus.uz">info@tashbus.uz</a>		
<b>Customer Purchase order #:</b>		Per email of 02.06.2023						<b>Customer PO Date:</b>		02.06.2023
<b>Repairing Outlet (Allison Dealer)</b>					Global Industrial Solutions					
<b>Transm. Model:</b>		T375			<b>PN:</b>		E027061		<b>SN:</b> 6511879677	
<b>Replacement Transmission:</b>					<b>PN:</b>				<b>SN:</b>	
<b>TCM, ECU, or Shift Sel.</b>					<b>PN 2:</b>		63CR0YQ8		<b>SN 2:</b>	
<b>Replacement TCM, ECU, or Shift Sel.</b>					<b>Replacement PN 2:</b>				<b>Replacement SN 2:</b>	
<b>Non-Allison Part</b>					<b>PN 3:</b>				<b>SN 3:</b>	
<b>Application:</b>		City Bus			<b>OEM:</b>		Yutong		<b>Model:</b> ZK6126HG

**Complaint:** Friday, 02.06.2023 DTC P0732 and DTC P2714. Transmission locks in 3<sup>rd</sup> range. According to the driver, the Tran

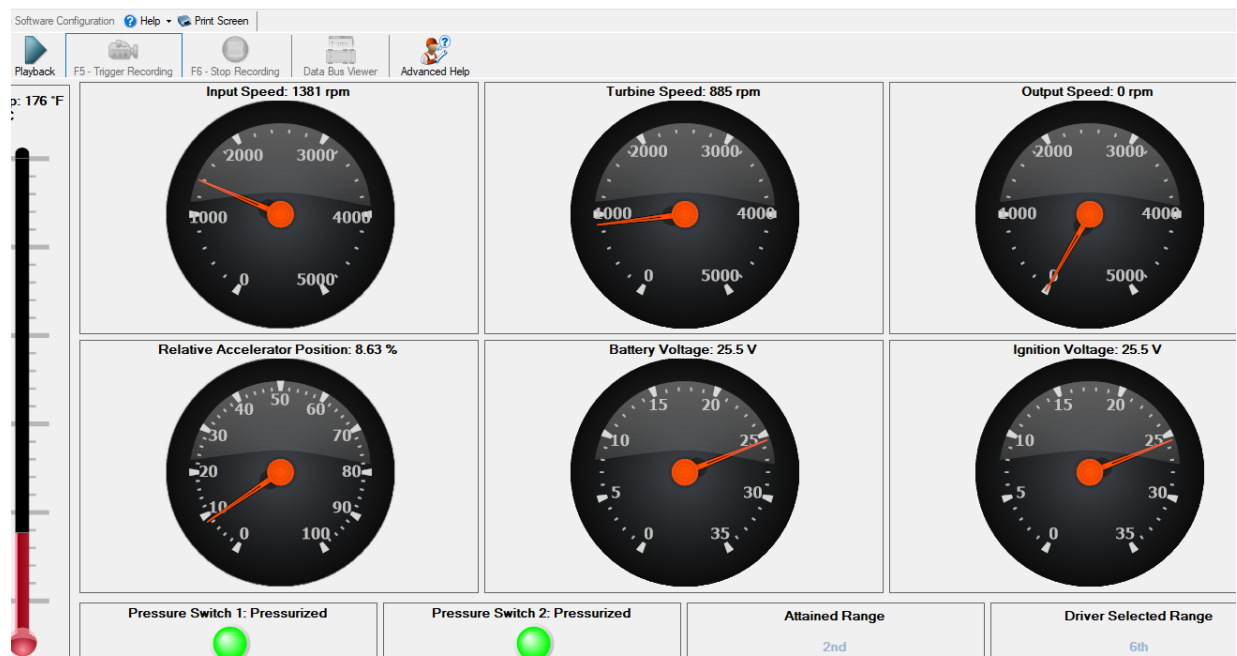
**Cause:** Slipping C4 clutch

- Checked oil level and found ok. But the Oil level had recently been corrected by either OEM Service or by customer fleet technician by having added 1 to 2 liters. Since required fluid spec was not on hand, any available oil was added. Unknown, which oil was added.
- Performed test drive to evaluate complaint. Found DTC P0732 occurring during a 1-2 upshift. The transmission consequently locked in 3<sup>rd</sup> range for fail safe operation.
- Checked all connectors and wiring. Visually ok.
- Performed clutch test with Allison DOC Diagnostic tool. **Found slip in 2<sup>nd</sup> range and in 6<sup>th</sup> range**, All other ranges are ok. This indicates C4 clutch is slipping under load. See DOV Snapshot file 6511879677-ClutchTest\_slip.ad4 , file time 00:01:26 and 00:02:35 (Bookmark #1 and #2) and file time 00:03:17 (Bookmark #3)

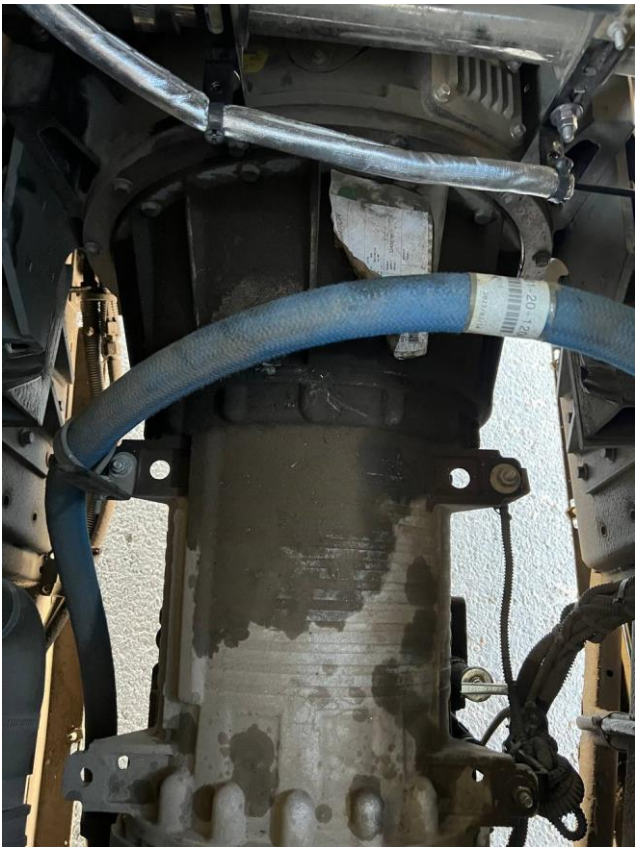
Transmission needs to be replaced and needs to be disassembled for further diagnosis and failure analysis. The transmission is wet of oil on the upper front part. Likely from breather blow-out or from another source of oil from above.
